Citation: Surre, F., Sun, T. & Grattan, K. T. V. (2013). Fiber Optic Strain Monitoring for Long-Term Evaluation of a Concrete Footbridge Under Extended Test Conditions. IEEE Sensors Journal, 13(3), pp. 1036-1043. doi: 10.1109/JSEN.2012.2234736

Fiber Optic Strain Monitoring for Long-Term Evaluation of a Concrete Footbridge under Extended Test Conditions

Abstract—An optical fiber sensor system that can be installed and used to give reliable and informative data has been developed, tested and evaluated, over an extended period of two years, on a redundant 50 year-old concrete foot bridge whose conditions of use were well known. The bridge now serves as an operational test-bed as it has been taken out of service, and recently has been subjected to different known environmental and loading conditions. Thus in this work, specific and controlled damage has been induced, the effects monitored and thus the changes induced to the bridge have been recorded, using the optical fiber sensor system over the test period. During this two year survey, issues relating to the installation, use, data capture and evaluation of performance not available in the present literature have been identified an

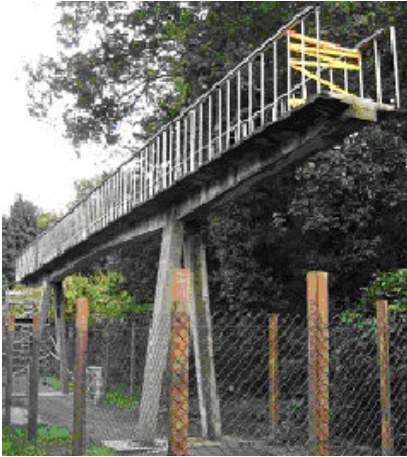
Fig. 1. Concrete footbridge at the National Physical Laboratory (© NPL).

A concrete footbridge on the premises of the National Physical Laboratory (NPL), Teddington, UK, was the ‘test-bed’ for this work. The bridge, shown in fig. 1, was built in the early 1960s and is built from reinforced concrete. The deck is 20m long; the piers are 5m high and the total weight of the bridge is 15tonnes. It had been in use for more than 40 years before it had been moved to its present location after its decommission to allow the test work to be done. Prior to that, new purpose-built concrete foundations had been created to support the bridge. As it is no longer in active use, it could be used as a test specimen, allowing loading at levels beyond what would be permissible with a ‘working bridge’ and allowing for accelerated damage situations to be created with it.
